Virginia Department of Forestry BMP Effort, Implementation, and Effectiveness Field Audit

November 2005

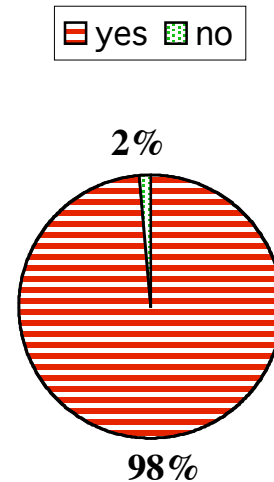
Fig. 1: Has An Effort Been Made To Apply BMPs, Regardless Of Meeting Technical Specifications?

Efforts to implement BMPs were evident at 98% of inspected timber harvests, up from the 97% recorded in June 2005, (*fig.1*). Quality of effort, rated on a scale of 1(poor) to 5(excellent), averaged 3.2, up from the 3.0 average of June 2005. Implementation of all necessary BMPs to DOF standards occurred at 18% of inspected sites, down from the 23% recorded in June 2005 (*fig. 2*).

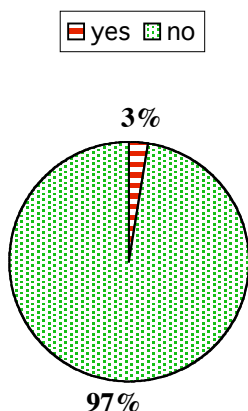
Fig. 3: Does Active Sedimentation Exist Now Because BMP Technical Specifications Were Not Met?

Active sedimentation existed at 3% of the inspected sites, down from the 7% recorded in June 2005, (*fig. 3*). The potential for sedimentation was noted at 10% of the inspected sites, down from the 13% noted in June 2005, (*fig. 4*).
